Safety Inspection Report

Annual Inspection

Play Area

16 April 2025

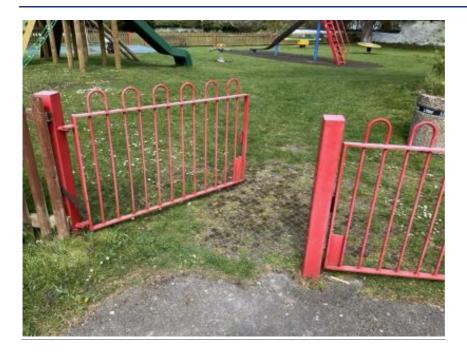
Gates

There is a crushing or shearing point on the side of the gate. Where the gaps reduce to less than 12 mm these have been known to cause serious, permanent injury to children, especially on the hinge side where the leverage forces are significant.

The gate's closing mechanism does not work correctly.

Adjust gate / posts / fit new rubber buffer to ensure a spacing of at least 12 mm throughout the range of the gate to remove the entrapment. The 12 mm gap also should apply on the hinge side of the gate.

Adjust to allow gate to self close. Ideally gate from open should not close in less than 5 seconds.

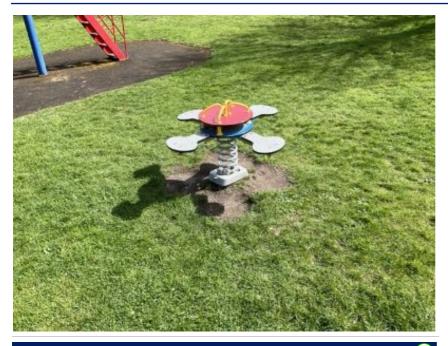
Rocker - Daisy

Surface is wearing.

Item is bent.

Seat frames x 2 bending. Refer to the manufacturer as additional fixings may be required.

Monitor for significant deterioration and rectify when necessary.

Read the notes for further action.

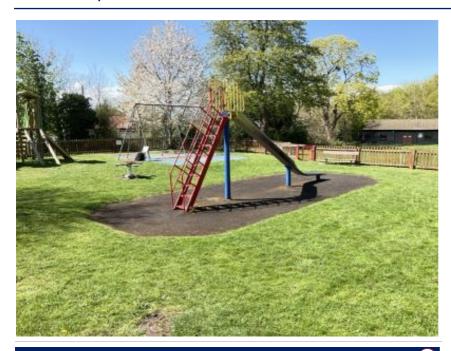
Slide - With Pedestal (2200 mm)

- 1. The spacing between the barrier bars is in excess of 89 mm.
- 2. There is a head entrapment.
- 3. There is a toggle entrapment.

The spacing between the barrier bars is in excess of 89 mm.

There is a head entrapment.

Between steps and barriers.

There is a toggle entrapment.

Surface is wearing.

The unit was installed prior to the publication of the current standards. There is no requirement to make retrospective changes.

Eliminate the entrapment.

Repair.

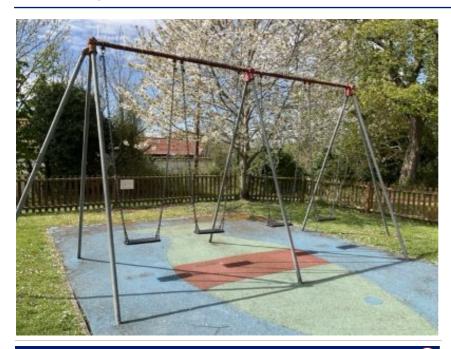
Swing - Junior - 2 Bay 4 Seat (2800 mm)

- 1. The dimension from the seat edge to the support is less than permitted.
- 2. The distance between the seats is insufficient.

- 1. Shrinkage / separation of the surface. This may give a trip hazard.
- 2. Encroaching vegetation or trees.
- 3. We are unable to gauge the structural integrity of this unit.
- 4. There is wear in the bushes.
- 5. Moss is present.

Shrinkage / separation of the surface. This may give a trip hazard.

Encroaching vegetation or trees.

We are unable to gauge the structural integrity of this unit.

There is wear in the bushes.

Bush x 1 worn. Replace.

Moss is present.

Allow grass to establish in the gap, as this may prevent the wet pour from shrinking further.

Cut back branches.

We advise an internal inspection of all parts or replacement.

Replace., Remove shackle bolt and check bush and shackle pin wear, replacing as necessary.

Remove.

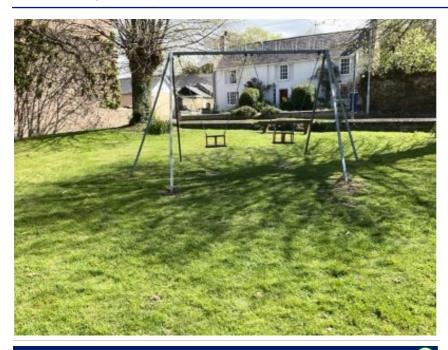
Swing - Toddler - 1 Bay 2 Seat (2400 mm)

Item is bent.

No reasonably practicable action is identified.

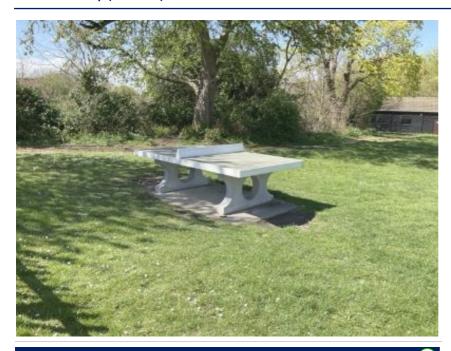
Table Tennis Table

Ground erosion present.

Consider adding grass matting to prevent wear.

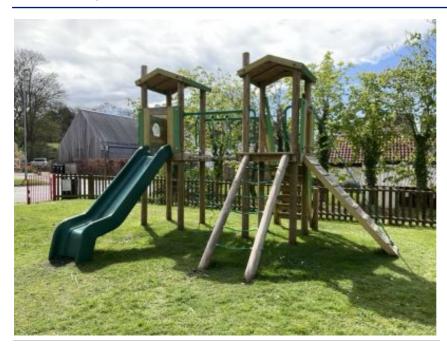
Multiplay - Slide Climber

There is a toggle entrapment.

There are natural splits / shakes in the timbers.

Surface needs repair.

Repair damaged grass mat.

Strimmer damage is present on posts, allowing water to enter and timbers to soften. It can also remove the protective envelope around the timber. Prevent further damage and check timbers for decay throughout the year.

Eliminate the entrapment.

DO NOT fill shakes. Monitor and sand back any splintered edges as required.

Repair.

Prevent further damage.
